East Missoula (MT 200) Road Safety Audit

Easy Street to Speedway Avenue

October 30, 2015

Montana Department of Transportation

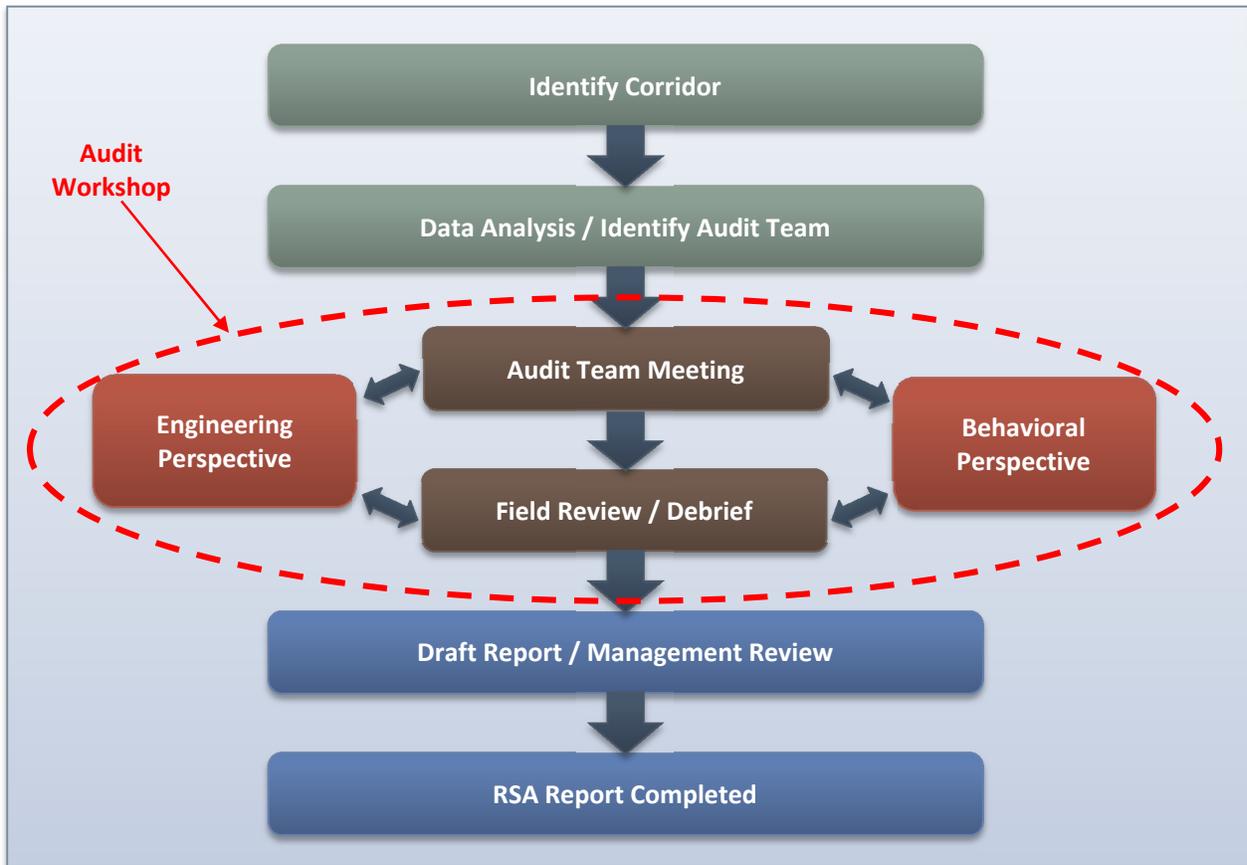
Figure 1.1: Road Safety Audit Flow Chart

The RSA process primarily revolves around a single event known as the "audit workshop." For the *East Missoula (MT 200) RSA*, the audit workshop was held on June 3, 2015. In order to fully understand the safety issues within this corridor, and to identify appropriate countermeasures, the audit workshop was conducted with a multi-disciplinary team of state, federal, and local authorities who have knowledge of safety and transportation issues specific to the corridor. **Figure 1.1** provides a graphical representation of the RSA process.

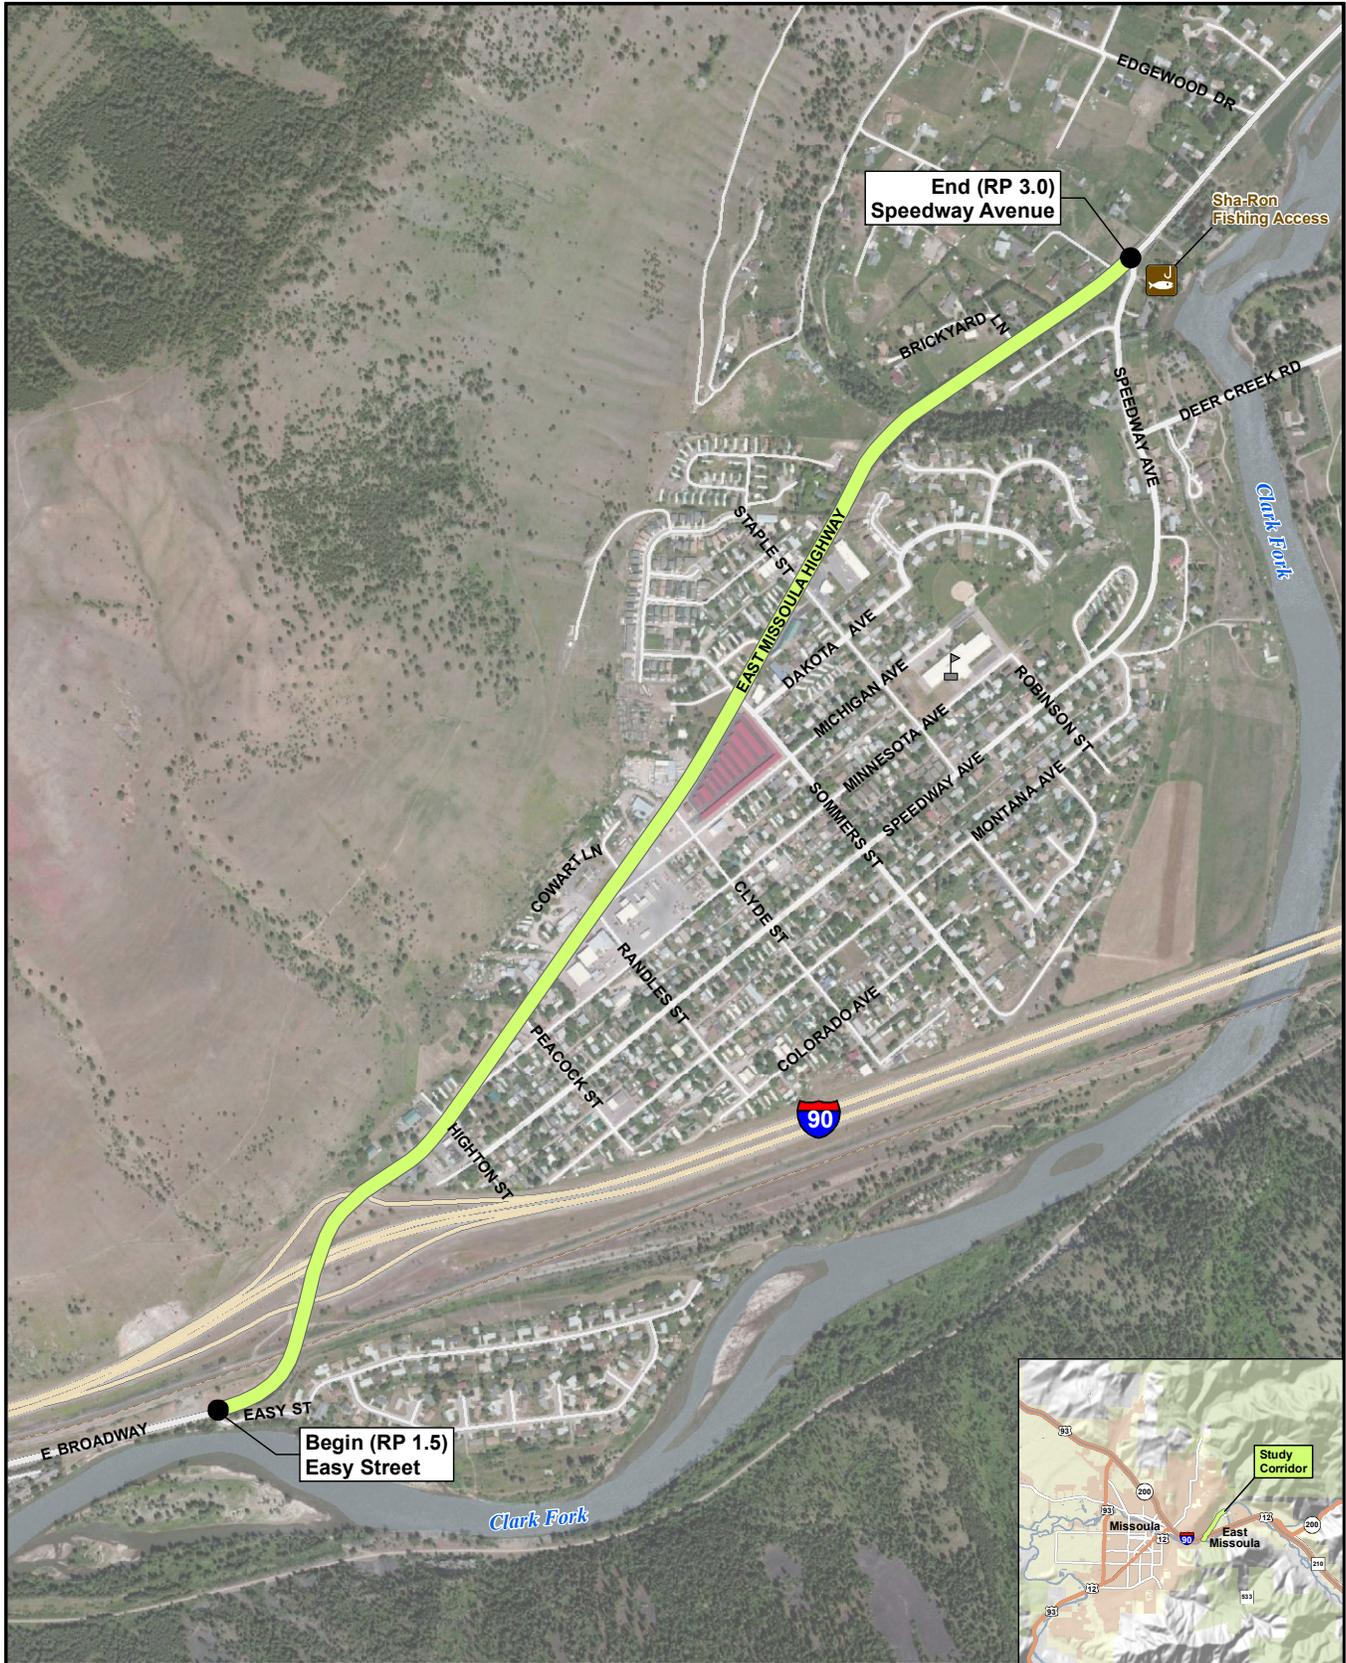
Figure 1.2: Study Area

The study area for this RSA includes the MT 200 corridor within East Missoula between Easy Street (Reference Post [RP] 1.5) and Speedway Avenue (RP 3.0). The study corridor is part of the East Missoula Highway Urban Route and is classified as a Minor Arterial roadway. The study area for the RSA is shown in **Figure 1.2**.

The MDT Traffic and Safety Bureau provided crash data for the 11-year period between January 1st, 2004 and December 31st, 2014. The crash data was evaluated for the MT 200 corridor between Easy Street and Speedway Avenue, as shown previously in **Figure 1.2**.

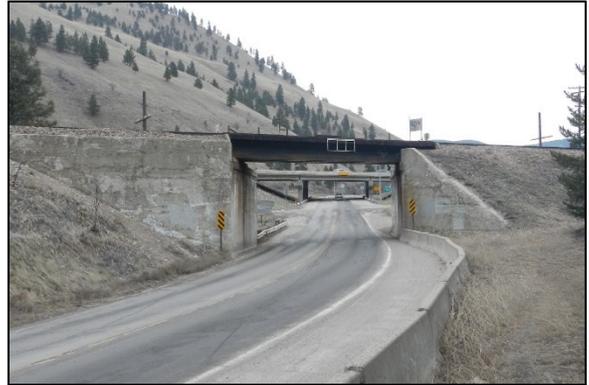
Photo 3.1: Railroad Underpass Looking North

The railroad underpass on the southwest end of the corridor is narrow and restricts sight distances. It was noted that this area receives additional traffic congestion related to special events on campus. No crashes were reported at this location, however, the following concerns were noted during both the field review and the audit meeting.

- **Narrow Width:** The narrow width of the underpass limits sight distance for vehicles traveling both east and westbound on MT 200. It was commented that it is easier to see vehicles traveling in the opposite direction at night due to the projection of the oncoming car's headlights on the underpass abutments.
- **Multi-modal Use:** Narrow shoulders inhibit pedestrian and bicycle traffic. Well-worn "desire lines" can be seen on the southeast side of MT 200. Next to the desire line is a concrete barrier rail that terminates at the underpass abutment. Non-motorized users are required to climb over the barrier rail and pass under the railroad along the edge of roadway. Both pedestrian and bicycle traffic were observed multiple times during the field review and audit session.

ID	Recommendation	Description	Follow-up	Timeframe
RAILROAD UNDERPASS / I-90 EASTBOUND OFF-RAMP				
E.1	Reduce sight obstructions	<p>Motorists traveling down the eastbound off-ramp suffer from limited sight distances due to the railroad and I-90 structures. In addition, there are multiple signs south of the intersection which may be distracting and restrict sight lines. It is recommended that the placement and need for the signs be evaluated to determine if sight lines may be improved.</p> <p><i>Following the audit, the cell phone use sign was relocated to help reduce sign clutter and improve sight lines.</i></p>	MDT, Missoula MPO	<p>Short-term</p> <p><i>Partially Completed</i></p>

ID	Recommendation	Description	Follow-up	Timeframe
E.2	Intersection Evaluation	There is a trend of crashes at the I-90 eastbound off-ramp intersection attributed to drivers not seeing conflicting traffic, particularly coming from the railroad underpass. It is recommended an intersection evaluation be completed to determine if a modification to the intersection is warranted. Options to be evaluated would include, but not be limited to: <ul style="list-style-type: none"> • Intersection conflict warning system (ITS solution) to warn motorists on the eastbound off-ramp of conflicting traffic along MT 200 to the south; • Roundabout or Mini-Roundabout; and • Traffic Signal. 	MDT, Missoula MPO	Short-term
E.3	Railroad underpass reconstruction	The existing railroad underpass is narrow and restricts sight distances. It is recommended that the underpass be reconstructed to increase sight distances and provide additional width to accommodate multi-modal use.	MDT, Missoula MPO, Missoula County	Long-term

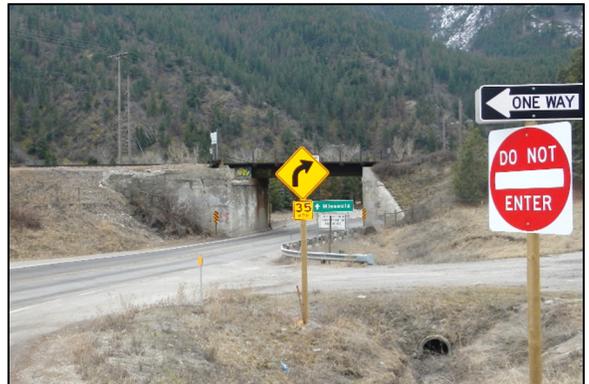
Photo 3.2: Looking South from Eastbound Off-ramp

- **Sight Distance:** It was noted during the field review that sight distance to the south of the eastbound off-ramp terminus is limited by signage and by the railroad underpass. The combination of the horizontal curve in MT 200 to the south and the narrow width of the underpass restrict sight distances. It was suggested that an intelligent transportation system (ITS) solution may help warn motorists of eastbound vehicles on MT 200. After the audit was conducted, the cell phone use sign attached to the City guide sign was relocated to help reduce sight obstructions.

- **Intersection Approach:** The eastbound off-ramp intersects with MT 200 at a skewed angle. During the field review, it was noted that motorists commonly pull past the stop bar and partially into the intersection to improve sight lines. Additionally, it was noted that the width and striping of the intersection allows for two vehicles to stop next to each other, effectively creating an unintended additional lane.

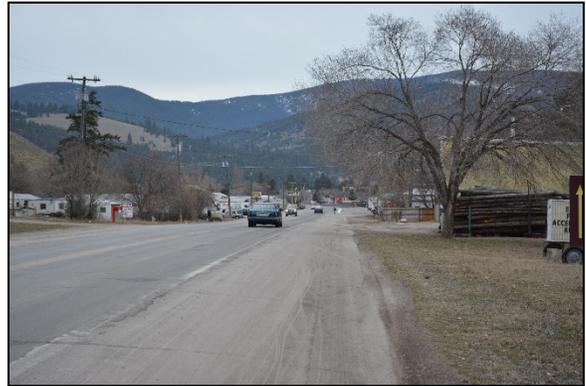
Photo 3.3: MT 200 Looking Northwest

- **Access Control:** Little to no access control is present on this section of the corridor. It was noted that parking occurs within the road right-of-way in some locations. Concerns were raised that increased access control could create access problems for trucks and delivery vehicles attempting to access businesses. A desire for a two-way left-turn lane (TWLTL) was expressed.

- **Angle of Intersections:** The intersection angle of many of the local streets is skewed. For vehicles attempting to access MT 200, it may require the driver to look behind themselves to see conflicting traffic. Additionally, vehicles leaving MT 200 may have to make tight turns or re-route altogether. At some intersections, it is also possible to maintain high speed while merging onto the local streets.

- **Non-motorized Facilities:** No pedestrian or bicycle facilities are present on this section of the study area. MT 200 has wide shoulders through this section, however, no bike lanes or sidewalks are present. There are also no marked crosswalks in this section of the corridor. It was noted that there is commonly pedestrian activity across the roadway between the Reno Café and Ole’s. Overhead street lighting was suggested as a way to improve pedestrian safety through town. Bicycle and pedestrian activity was noted during the field reviews.

URBAN AREA (I-90 INTERCHANGE TO SOMMERS STREET)				
E.4	Striping and delineation	The MT 200 corridor through East Missoula has an undefined wide shoulder and unmarked access points. It is recommended that the corridor be striped and delineated to better define the shoulders and access points.	MDT	Short-term
E.5	Access control plan	A trend of access-related crashes was identified through the urban area of East Missoula. The corridor currently lacks definition for accesses. It is recommended that an Access Control Plan be developed to define where access points should exist.	MDT, Missoula MPO	Mid-term
E.6	Street lighting	MT 200 through East Missoula is unlit and difficult to see at night. It is recommended that street lighting be evaluated along the corridor to improve nighttime visibility for motorists and pedestrians.	MDT, Missoula MPO	Mid-term
E.7	Reconstruction	The MT 200 corridor is wide, lacks defined access points, has poor drainage, and has deteriorating surfacing. It is recommended that the MT 200 corridor through East Missoula be reconstructed to incorporate recommendations made in the proposed Access Control Plan and to provide for a TWLTL, turn bays at major intersections, multi-modal accommodations, and improved drainage.	MDT, Missoula MPO	Long-term

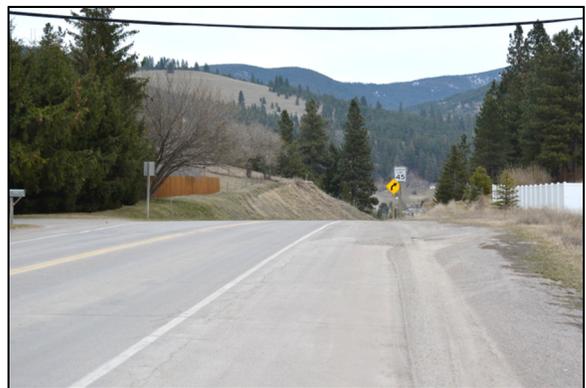
Photo 3.4: Northeast of Staple Street Looking Northeast

Eight crashes were reported in the vicinity of Staple Street, four of which were intersection related. One of the non-intersection related crashes was reported as occurring to the southwest of Staple Street, while the remaining three crashes occurred northeast of Staple Street.

- **Crosswalk:** A marked crosswalk is located at the intersection with Staple Street. A Mountain Line bus stop is located just off of MT 200 on Staple Street. The crosswalk connects the neighborhood to the west with the bus stop on the east side of MT 200. It was commented that pedestrians use a trail behind the business development and church to the northeast to access a park on Dakota Avenue.
- **Vehicle Speeds:** A speed study was performed by MDT in 2012 which recommended the 35 mph speed zone be extended to the bottom of the Brickyard Hill. Previously, the speed zone ended just southwest of the intersection with Staple Street. The existing speed limit signs are located

approximately 400 feet southwest of the recommendations made in the speed study due to site constraints and visibility concerns. The speed zone currently ends at the top of Brickyard Hill.

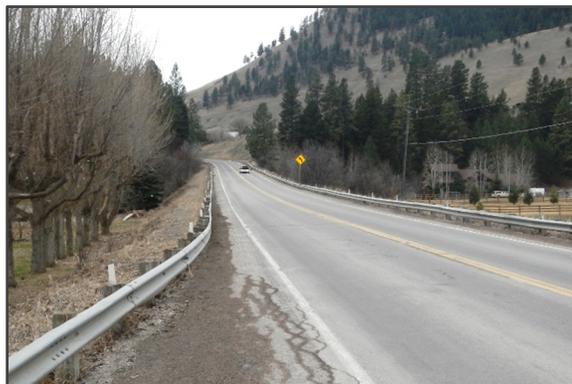
Photo 3.5: Brickyard Hill Looking Southwest

Brickyard Hill consists of a six percent grade between Staple Street and Brickyard Lane. A total of seven crashes were reported to have occurred on Brickyard Hill. Of these seven crashes, two were head on crashes, both of which resulted in a fatality.

- **Road Conditions:** It was noted that Brickyard Hill tends to remain icy longer than other portions of the corridor due to the hillside blocking sunshine during the winter months. It was also commented that there have been times when school busses were unable to travel up the hill due to the icy conditions. One of the fatal head on crashes occurred during icy road conditions. The existing posted speed limit on Brickyard Hill is 45 mph.

BRICKYARD HILL				
E.8	Speed limit sign	The existing 35 mph speed zone ends at the top of Brickyard Hill. The Transportation Commission approved the speed zone to extend to the bottom of Brickyard Hill. It is recommended that the 35 mph speed zone be extended to incorporate Brickyard Hill.	MDT	Short-term
E.9	Warning sign	Brickyard Hill receives little sunlight during the winter months. The lack of sunlight and steep grade make inclement weather conditions particularly hazardous at this location. It is recommended that the installation of additional warning signs (ITS or static) advising of potential poor road conditions be evaluated at this location.	MDT	Short-term (static) Mid-term (ITS)
SPEEDWAY AVENUE				
E.10	Delineation	The intersection lacks definition and has a mountable median which is difficult to see. It is recommended that the median be painted and delineation be added to improve visibility and definition of the intersection. <i>Following the audit, the median perimeter was painted, flexible delineation was installed, the centerline was repainted, and the signing was improved.</i>	MDT	Short-term <i>Already completed</i>

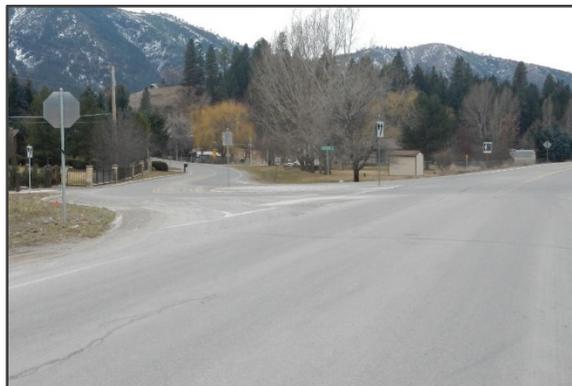
Photo 3.6: Speedway Avenue Intersection Looking South

Five crashes were reported to have occurred at the intersection of Speedway Avenue with MT 200. The intersection was reconstructed in 2012 to improve geometrics. Of the five crashes, three occurred prior to the reconstruction and the remaining two occurred after.

- **Intersection Layout:** The intersection of Speedway Avenue and MT 200 has a mountable raised median on Speedway Avenue. The intersection is stop controlled on Speedway Avenue. Concerns were expressed that the median is hard to see and may cause confusion. When traveling southbound, it is difficult to see the entrance. After the audit, the median perimeter was painted, flexible delineation was installed, the centerline along MT 200 was repainted, and the “keep right” sign was repositioned to better face the approaching traffic.
- **Recreational Users:** The Sha-Ron Fishing Access is a popular summer time location for recreational users. It was stated that during peak usage times, the fishing access reaches parking capacity and users park on the shoulders of Speedway Avenue and MT 200. No crashes were reported to have resulted from this activity.
